TECHNICAL REPORT REMR-CO-3

CASE HISTORIES OF CORPS BREAKWATER  
AND JETTY STRUCTURES

Report 3  
NORTH CENTRAL DIVISION

Robert R. Bottin, Jr.

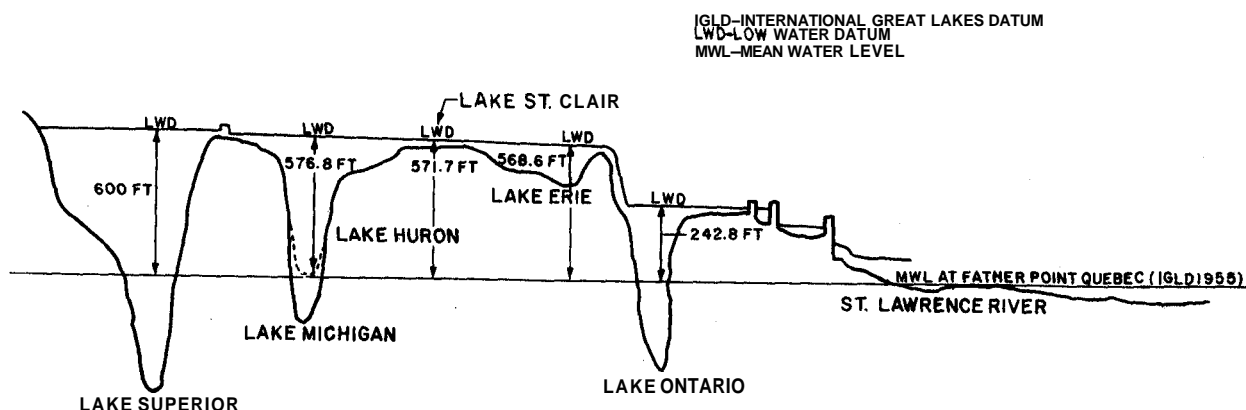
Figure 4. Profile of the Great Lakes region (lwd referenced to mw1 at Father Point, Quebec according to IGLD of 1955)

6. The els of various structures and depths on the Great Lakes are based on low water datum (lwd) which is referenced to mean water level (mw1) at Father Point, Quebec, according to the International Great Lakes Datum (IGLD) of 1955. Figure 4 shows a profile of the Great Lakes region. Horizontal and vertical distances have been distorted somewhat to convey visual impression.

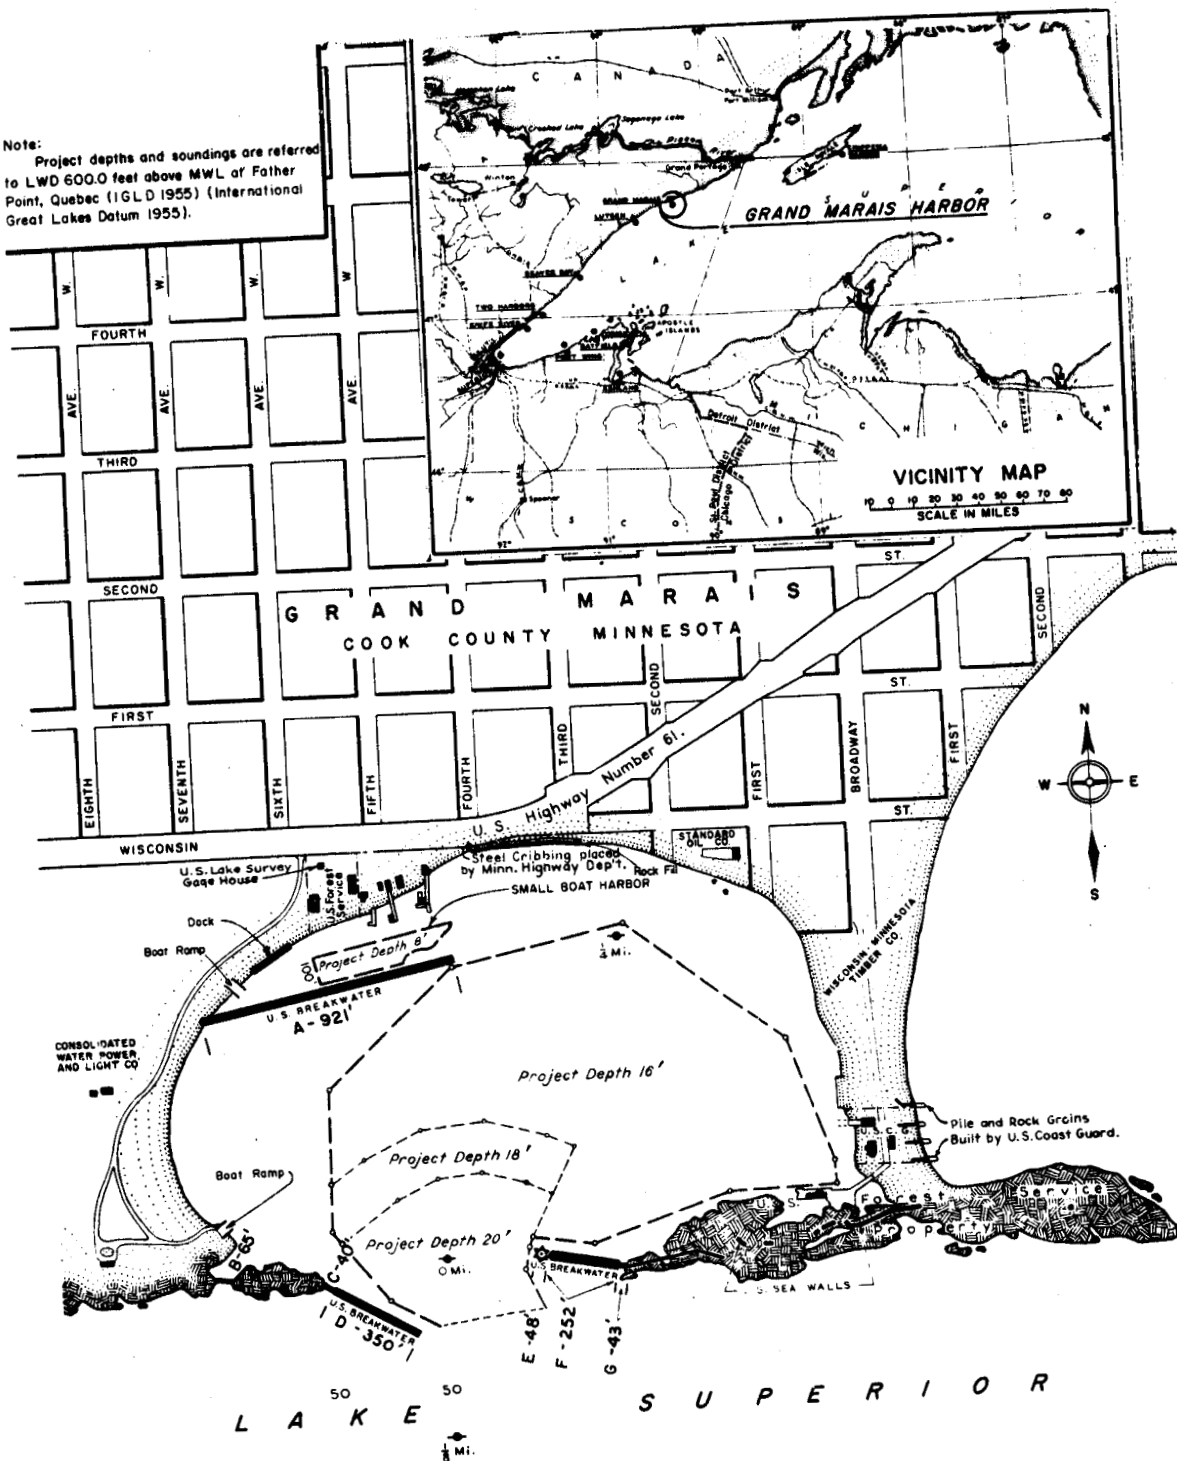
Figure 5. Grand Marais Harbor, Minnesota

Date(s)	Construction and Rehabilitation History
1883-1884	A 300-ft-long rock-filled timber-crib breakwater was constructed at the site (Figure 5, Sections E and F) during this period. The outer 48 ft of the structure (Figures 5 and 6, Section E) was built 40 ft in width, and the remaining 252 ft (Figures 5 and 6, Section F) was constructed 30 ft in width.
1901-1902	A 350-ft-long rock-filled timber crib breakwater was constructed west of the first structure during this period (Figures 5 and 6, Section D). The structure was built 24 ft wide.
1925	A concrete cap (superstructure) was constructed on the outer 48 ft of the structure built during 1883-84. The crest el was +7 ft lwd (Figure 6, Section E).
1926	A concrete cap (superstructure) was completed on the 30-ft-wide, 252-ft-long structure built during 1883-84. The crest was constructed at an el of +7 ft lwd (Figure 6, Section F).
1933	A concrete cap (superstructure) was installed on the breakwater built during 1901-02. The crest el was +7 ft lwd. Heavy riprap was placed on both sides of the structure (Figure 6, Section D). Also in 1933 a 43-ft-long concrete breakwater connecting the east breakwater to shore was constructed (Figure 5, Section G). The structure was 12 ft wide and had a crest el of +7 ft lwd (Figure 6, Section G).

1959	Construction of a 921-ft-long rubble-mound inner breakwater was completed (Figure 5, Section A). Cover stone, a minimum of 2 tons, was placed on the outer 550 ft of the structure, and 1-ton (minimum) cover stone was placed on the remaining part of the breakwater. The crest el was +6 ft lwd with an 8-ft width. The structure had side slopes of 1V:1.5H (Figure 6, Section A). The inner breakwaters were model tested (Fenwick 1941, 1944).
1972	A 65-ft-long rubble-mound breakwater connecting the shore to an island (Figure 5, Section B) and a 40-ft-long rubble-mound breakwater connecting the island to the east breakwater (Figure 5, Section C) were constructed. These structures were built with stone ranging from 5 to 20 tons and had crest els of +6 ft lwd (Figure 6, Sections B and C). Model testing of these structures was conducted (Fenwick 1941).
1981	A survey of the structures revealed spalling of the concrete at several locations, particularly on the lakeside of the east breakwater. The rubble-mound shore connection of the west breakwater required

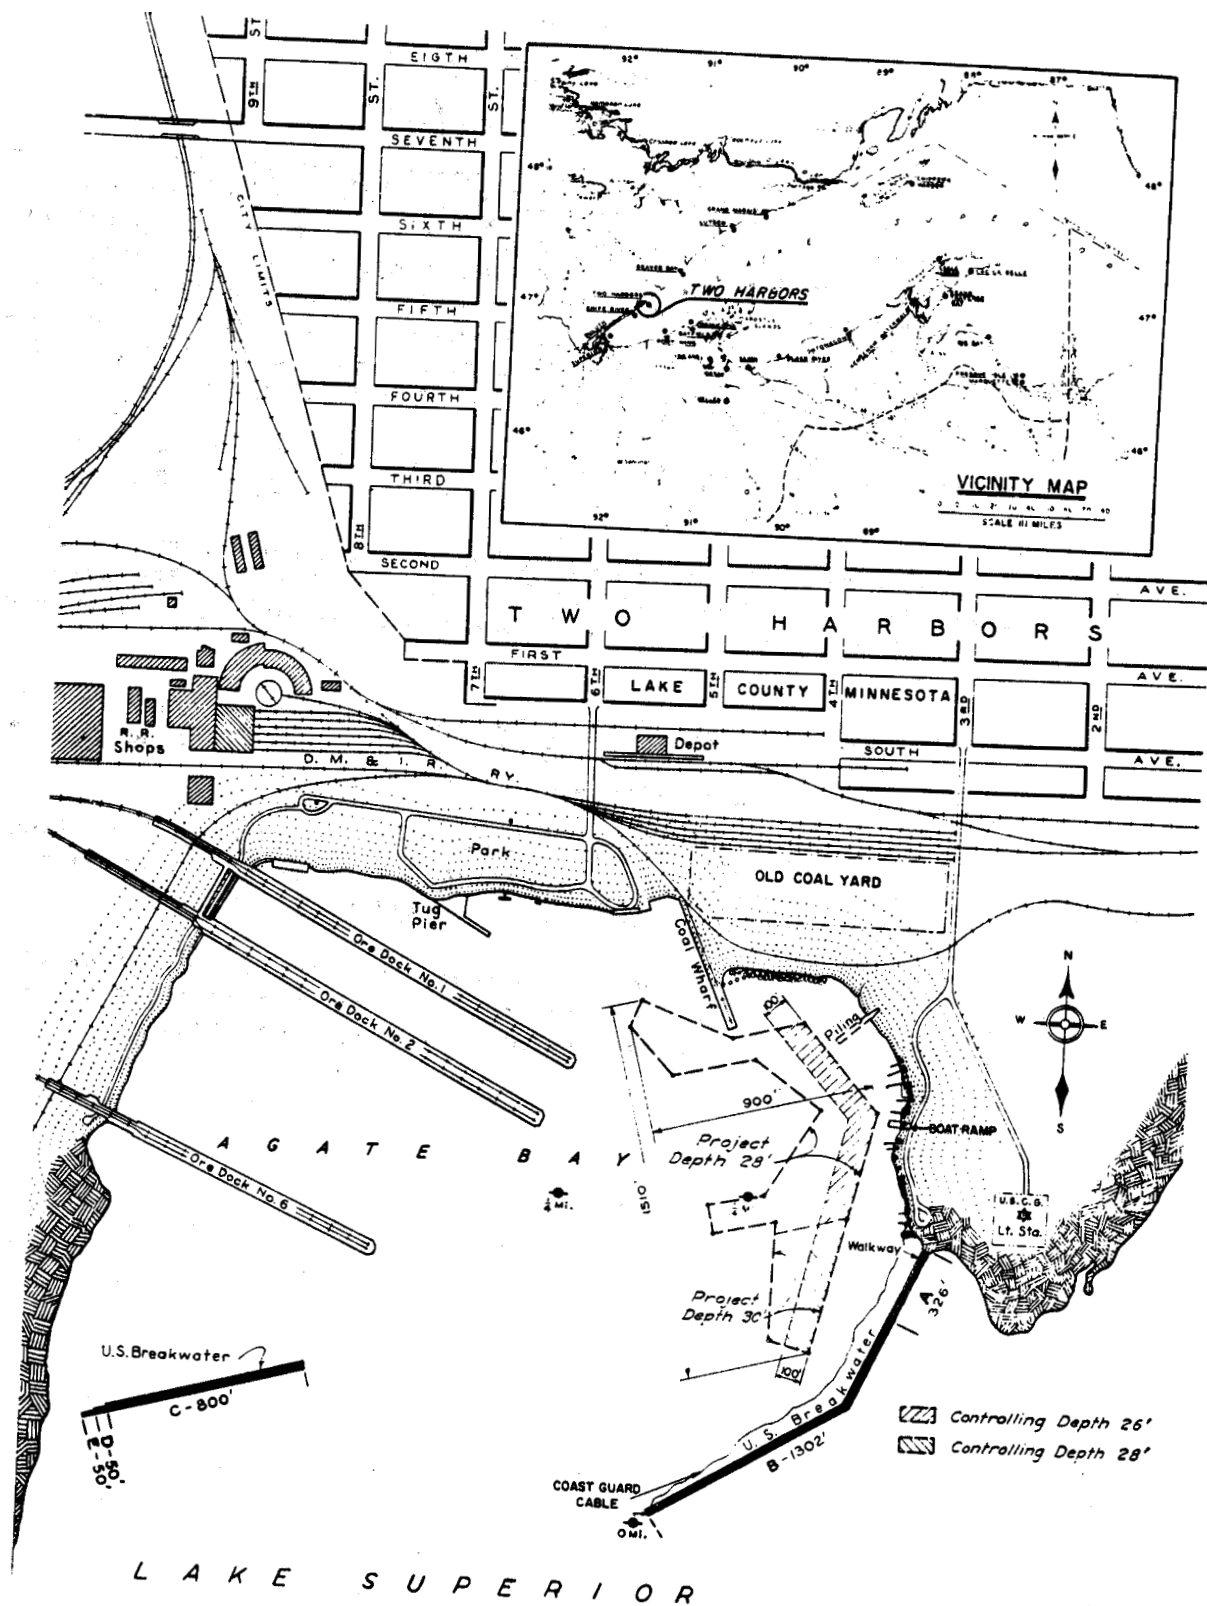
Figure 7: Two Harbors, Minnesota

Date(s)	Construction and Rehabilitation History
1893	Construction of a 900-ft-long stone-filled timber crib breakwater (Figure 7, Sections C, D, and E) was completed at the site. The cribs were built on rubble-mound foundations. The easternmost 800 ft of the structure was 24 ft wide (Figure 8, Section C), the adjacent 50-ft portion was 20 ft wide (Figure 8, Section D), and the westernmost 50 ft of the breakwater was 16 ft wide (Figure 8, Section E).
1933- 1934	A concrete cap (superstructure) was built on the breakwater. The crest el was +7 ft lwd (Figure 8, Sections C, D, and E).
1947- 1949	A 1,302-ft-long stone-filled timber crib breakwater on a rubble-mound base was constructed (Figures 7 and 8, Section B). The structure was 30 ft wide. The rubble-mound base consisted of 5-ton cover stone on 1V:1.5H side slopes.
1948	Construction of a 326-ft-long rubble-mound shore connection of the east breakwater was completed (Figures 7 and 8, section A). The crest was 12 ft wide with a +6 ft crest el.

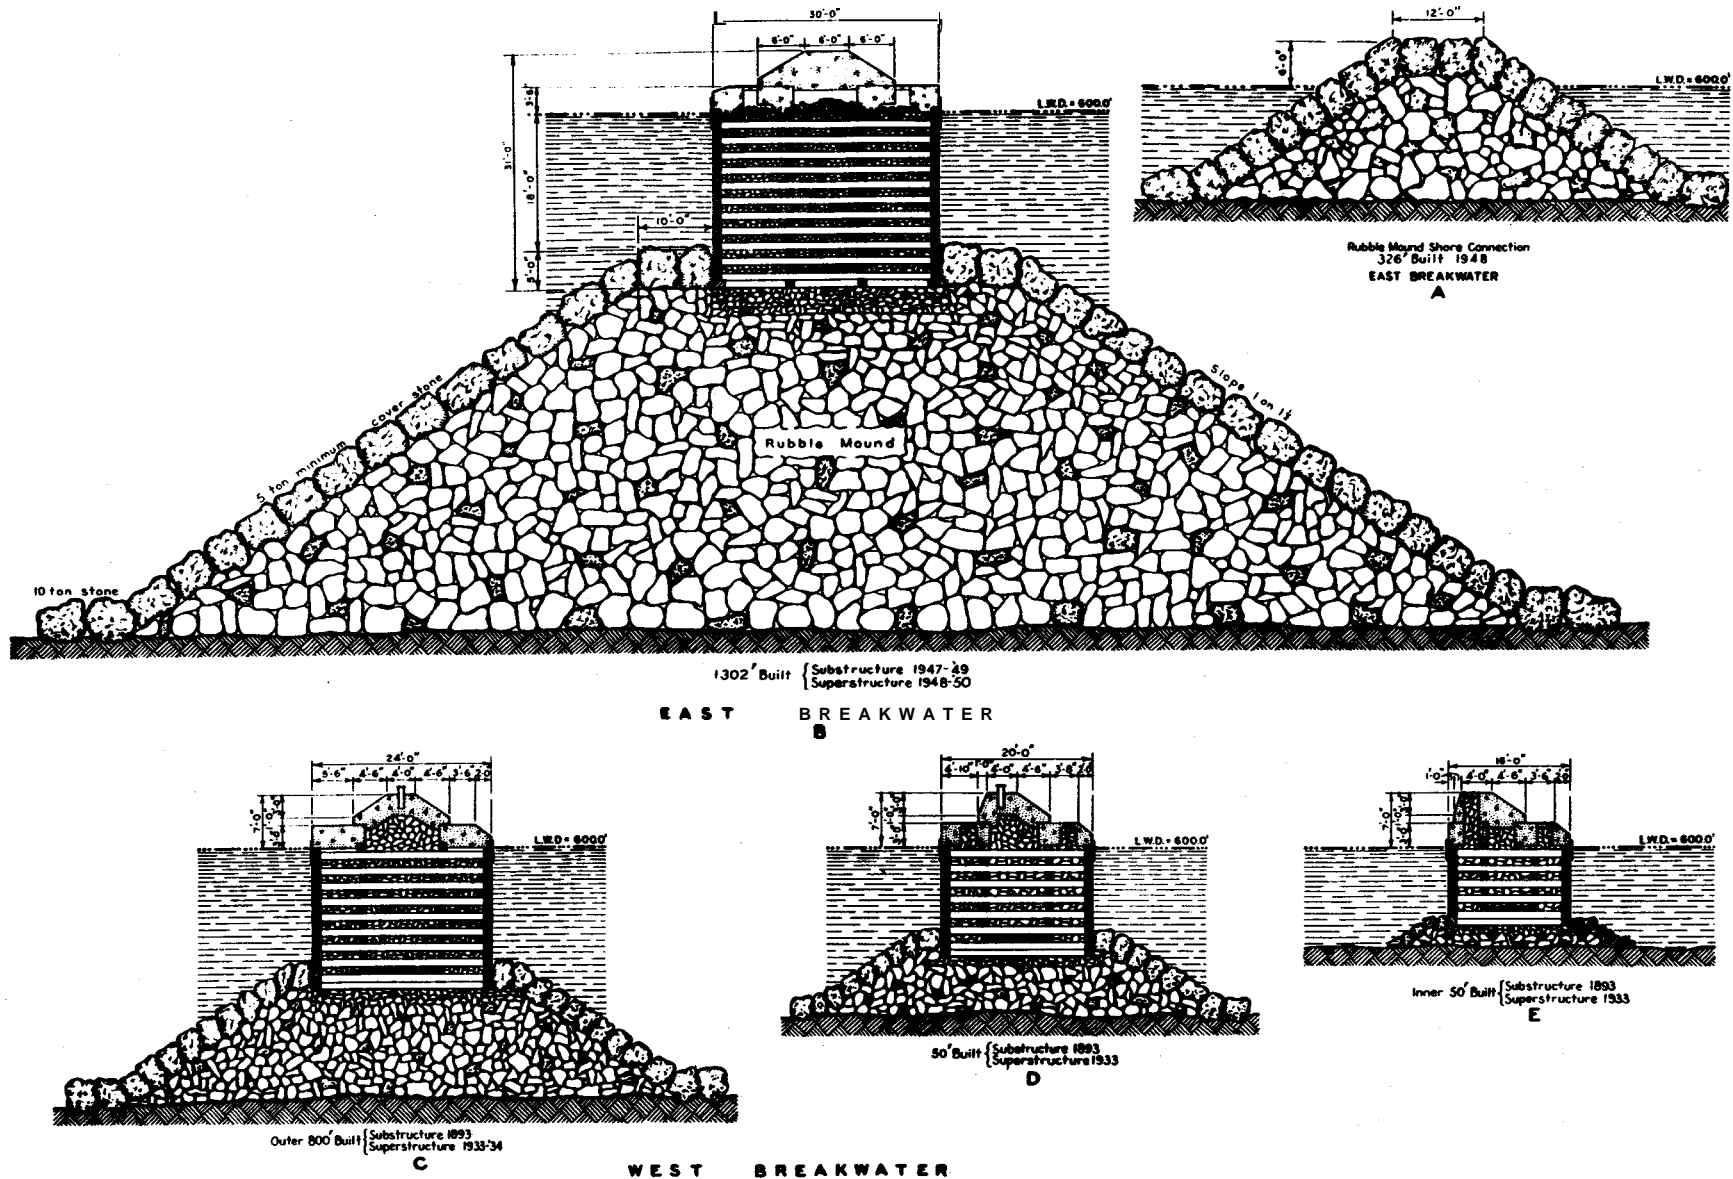
Figure 8 Typical structure cross sections Two Harbors, Minnesota

1948- 1950	A concrete cap (superstructure) was built on the 1,302-ft-long breakwater that was completed during 1947-49 (Figure 8, Section B). The crest el of the structure was increased to +8 ft.
1986	Since construction, records indicate that localized damage of the breakwaters has occurred and has been repaired during routine maintenance. The structures are presently in good condition.

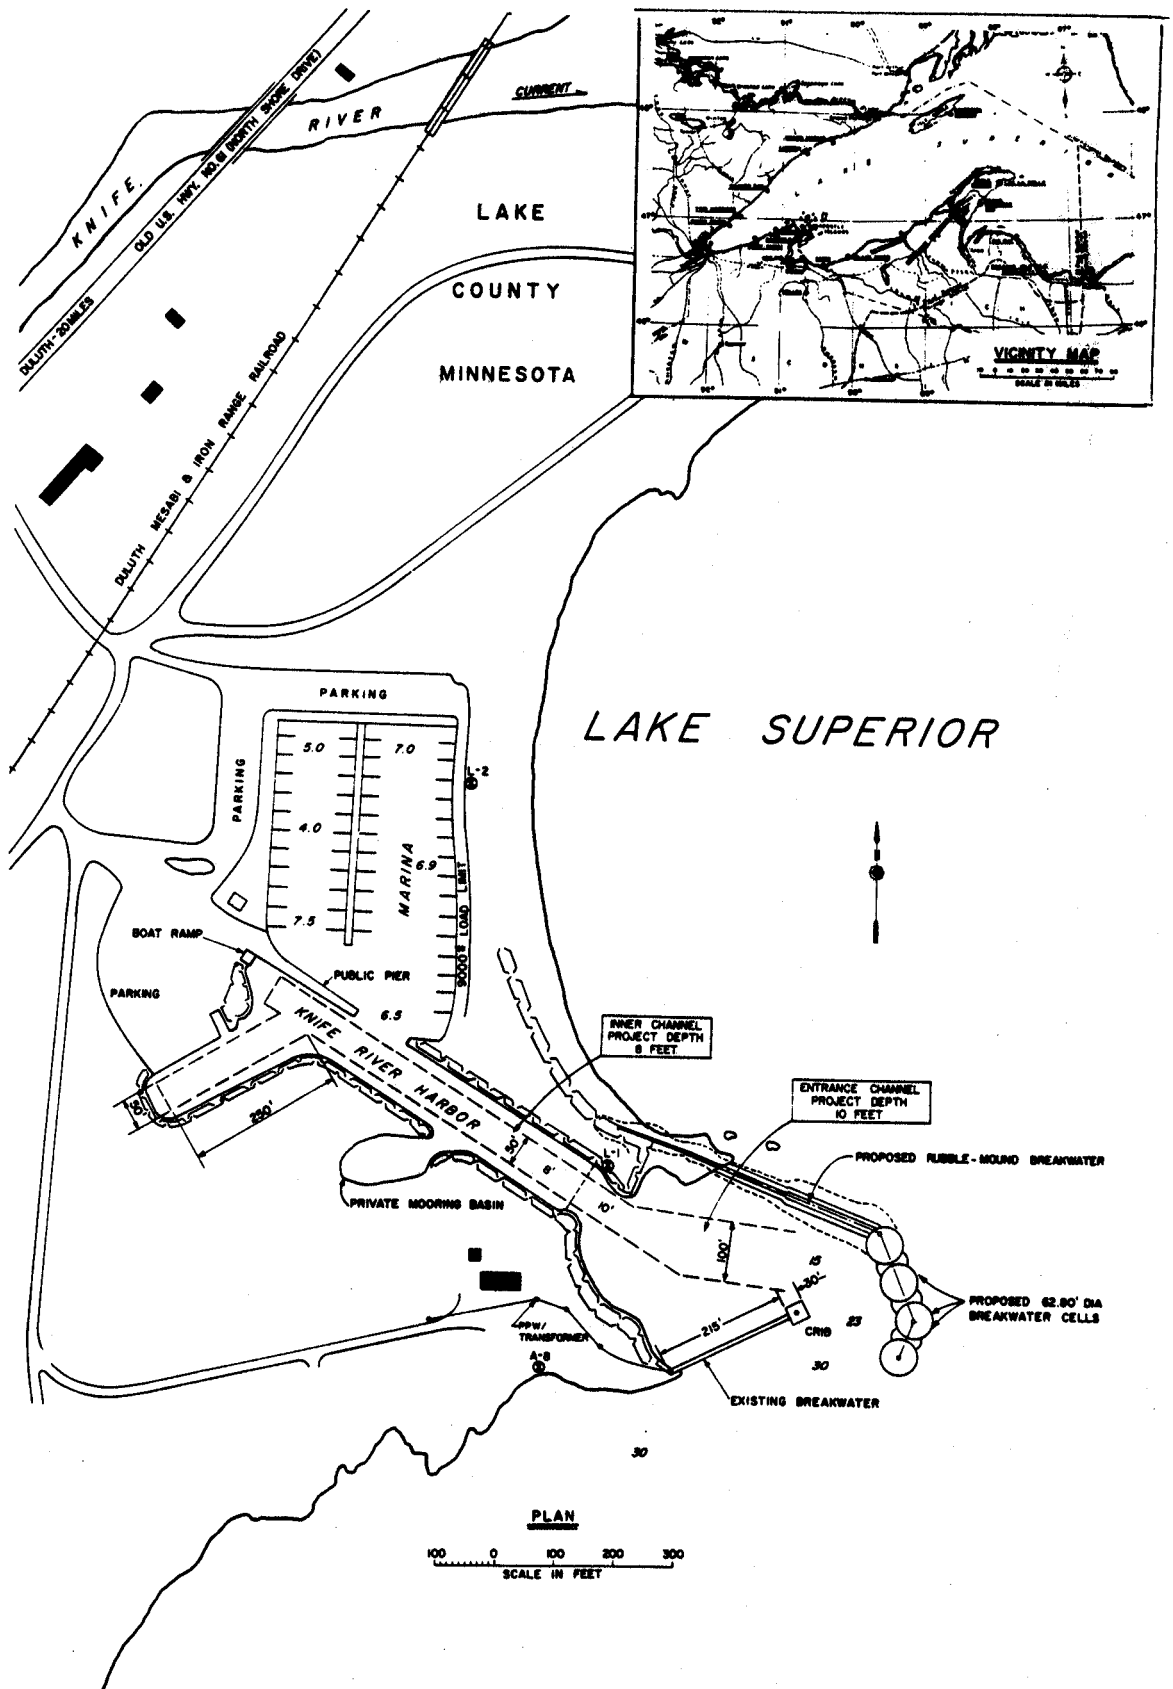
Figure 9. Knife River Harbor, Minnesota

Date(s)	Construction and Rehabilitation History
1957- 1958	Construction of a 245-ft-long breakwater occurred at the site (Figure 9) during this time frame. The shoreward 215 ft of the structure was of rubble-mound construction, and the lakeward <b>30</b> ft was a stone-filled timber crib breakwater (Figure 10). The rubble-mound portion of the breakwater had a crest width of 8 ft and an el of +8 ft lwd. Side slopes of <b>1V:1.5H</b> were constructed, and armor stone ranging from <b>3</b> to 5 tons was used. The timber crib structure was <b>30</b> ft wide with a crest el of +9 ft lwd. It was constructed on a stone mattress and had a timber deck. Rock was placed around the toe of the structure comprised of cover stone ranging from 1 to 5 tons. After construction it was noted that a design deficiency existed in that the breakwater did not effectively protect the harbor entrance from adverse wave conditions from northeasterly storms.

1974	A modification to the project authorized the construction of a 451-ft-long rubble-mound breakwater with four 62.8-ft <b>diam</b> steel sheet-pile cells (250 ft) at its head (Figure <b>9</b> ). Construction of the breakwater has not been initiated.
1986	Since the original breakwater was completed, it has sustained some localized damage which was repaired during routine maintenance. The structure is presently in good condition.

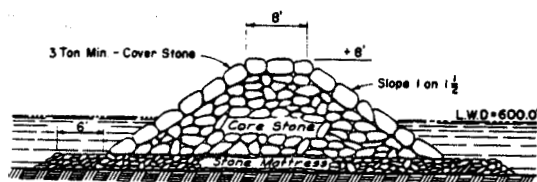
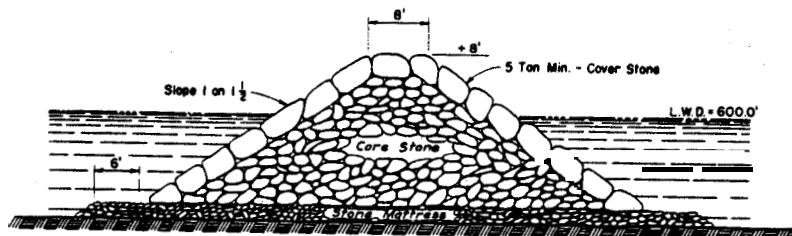
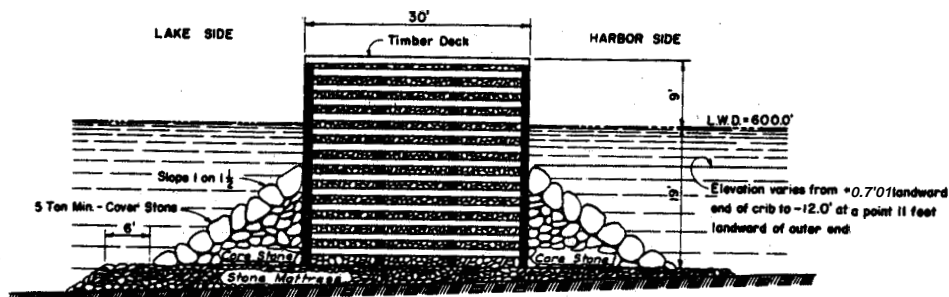
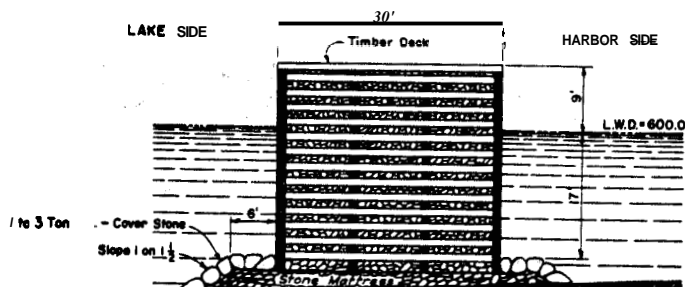
**RUBBLE MOUND**  
Landward End to L.W.O. Shore Line  
Built 1957-1958

**RUBBLE MOUND**  
L.W.O. Shore Line to -10 Contour  
Built 1957-1958

**RUBBLE MOUND**  
-10 Contour to Landward End of Crib  
Built 1957-1958

**TIMBER CRIB**  
Landward 25'  
Built 1957-1958

Figure 10. Typical structure cross sections,  
Knife River Harbor, Minnesota

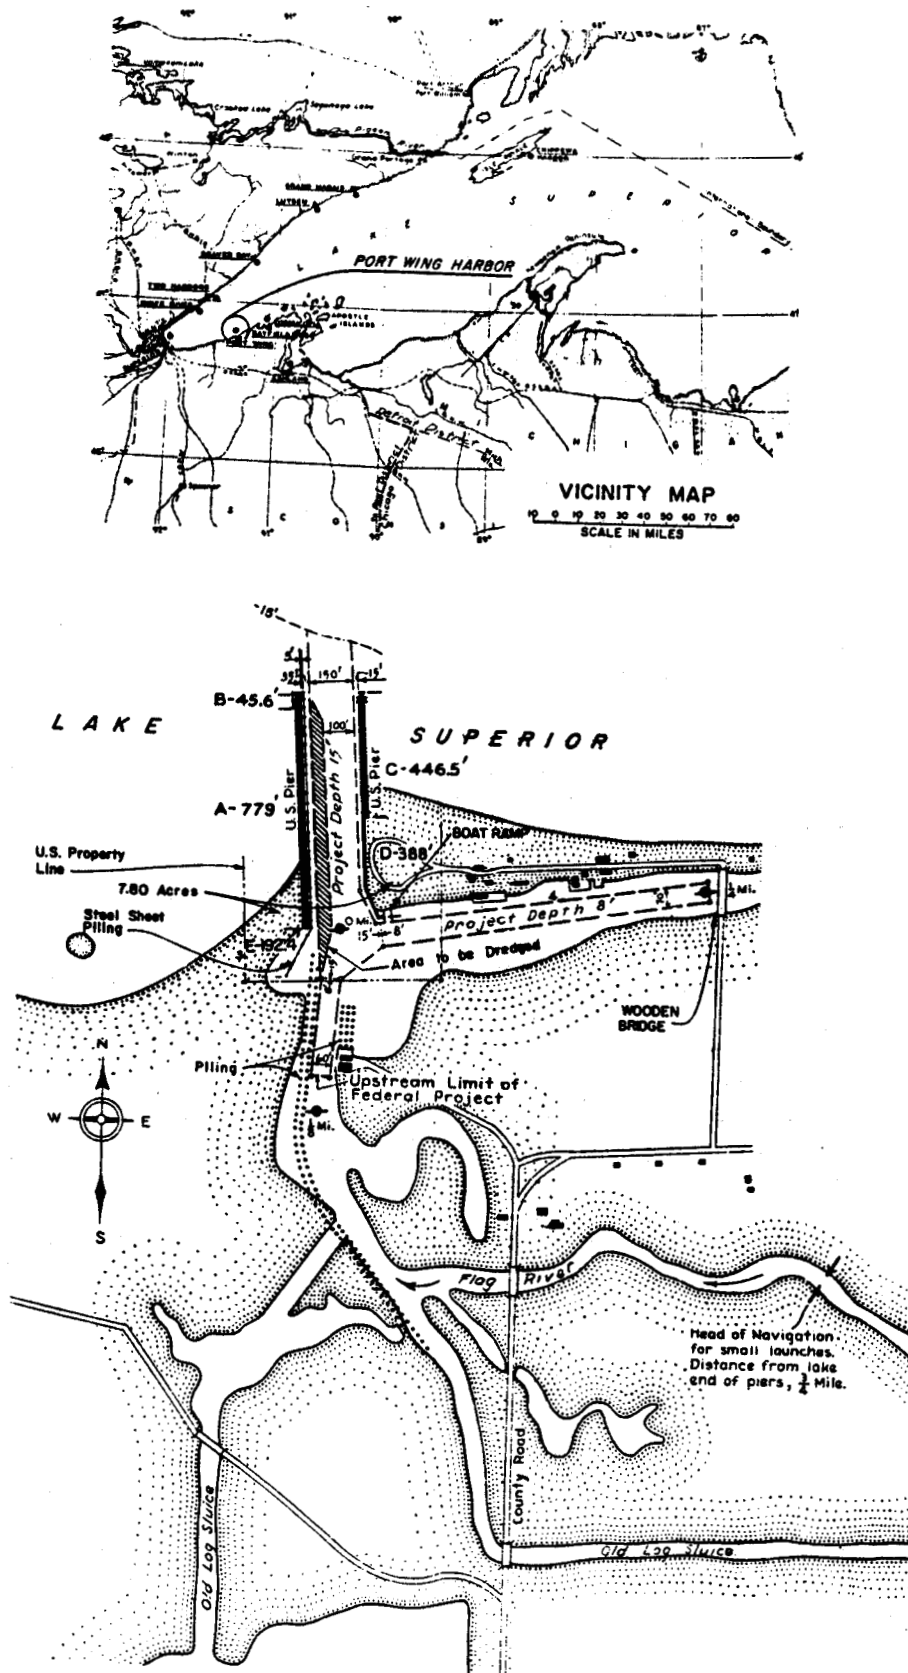
Figure 13. Port Wing Harbor, Wisconsin

Date(s)	Construction and Rehabilitation History
1903- 1904	The construction of an 800-ft-long east pier and a 45-ft-long pile revetment progressed at the site (Figure 13).
1906	The outer 555 ft of the west pier (Figure 13, Section A) was constructed. The structure consisted of wood piles filled with wood slabs and capped with stone. It was 11 ft wide and installed at an el of +5.5 ft lwd.
1917	The inner 224 ft of the west pier was constructed. The cross section of the structure was the same as the outer portion built in 1906.
1946	The outer portion of the west pier (45.6 ft long) was rebuilt (Figures 13 and 14, Section B). Steel sheetpiling and stone were used to increase the width of the structure to 18.7 ft. Large stone was used to cap the structure. The crest el was +5 ft lwd.
1949- 1950	The east pier and pile revetment were rebuilt. The east pier consisted of wood piles filled with stone and capped with a concrete and stone superstructure. The crest el of the structure was +5.5 ft lwd with a 19.75-ft width, and the length was decreased to 446.5 ft. Stone was placed on the lakeside of the pier (Figure 14, Section C). The pile revetment consisted of woodpiling filled with sand and capped with concrete. It was increased to 388 ft in length. The el was +4.0 ft lwd, and stone was placed on the channel side (Figure 14, Section D).

1961	Steel sheetpiling was placed on the shoreward end of the west pier for a distance of 192.4 ft (Figures 13 and 14, Section E). The structure was 1.0 ft wide at an el of +5.5 ft lwd. A rock berm was installed on each side of the structure (Figure 14, Section E). Steel sheetpiling was also placed on the channel side of the west pier for a distance of 779 ft (Figures 13 and 14, Section A).
1986	The structures presently are in good condition.

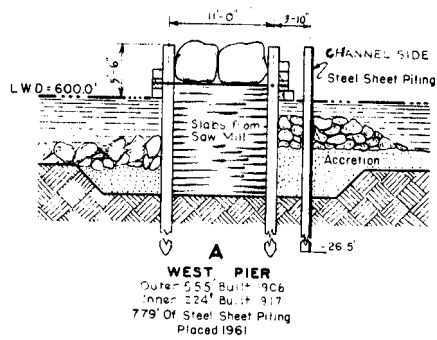
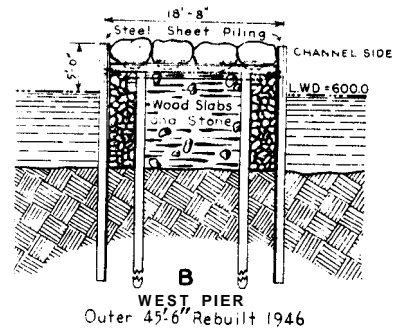
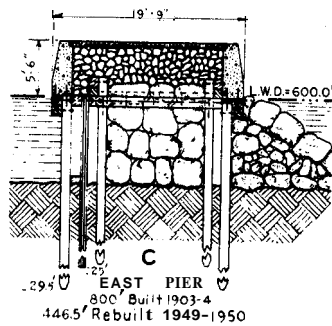
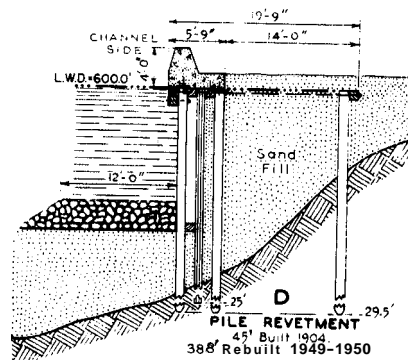
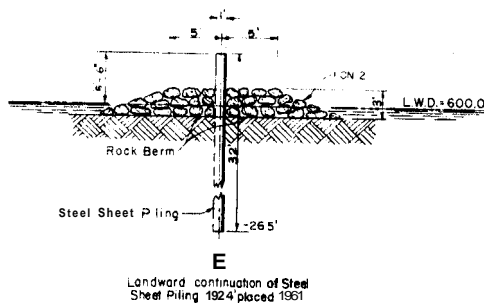
Figure 14. Typical structure cross sections,  
 Port Wing Harbor, Wisconsin

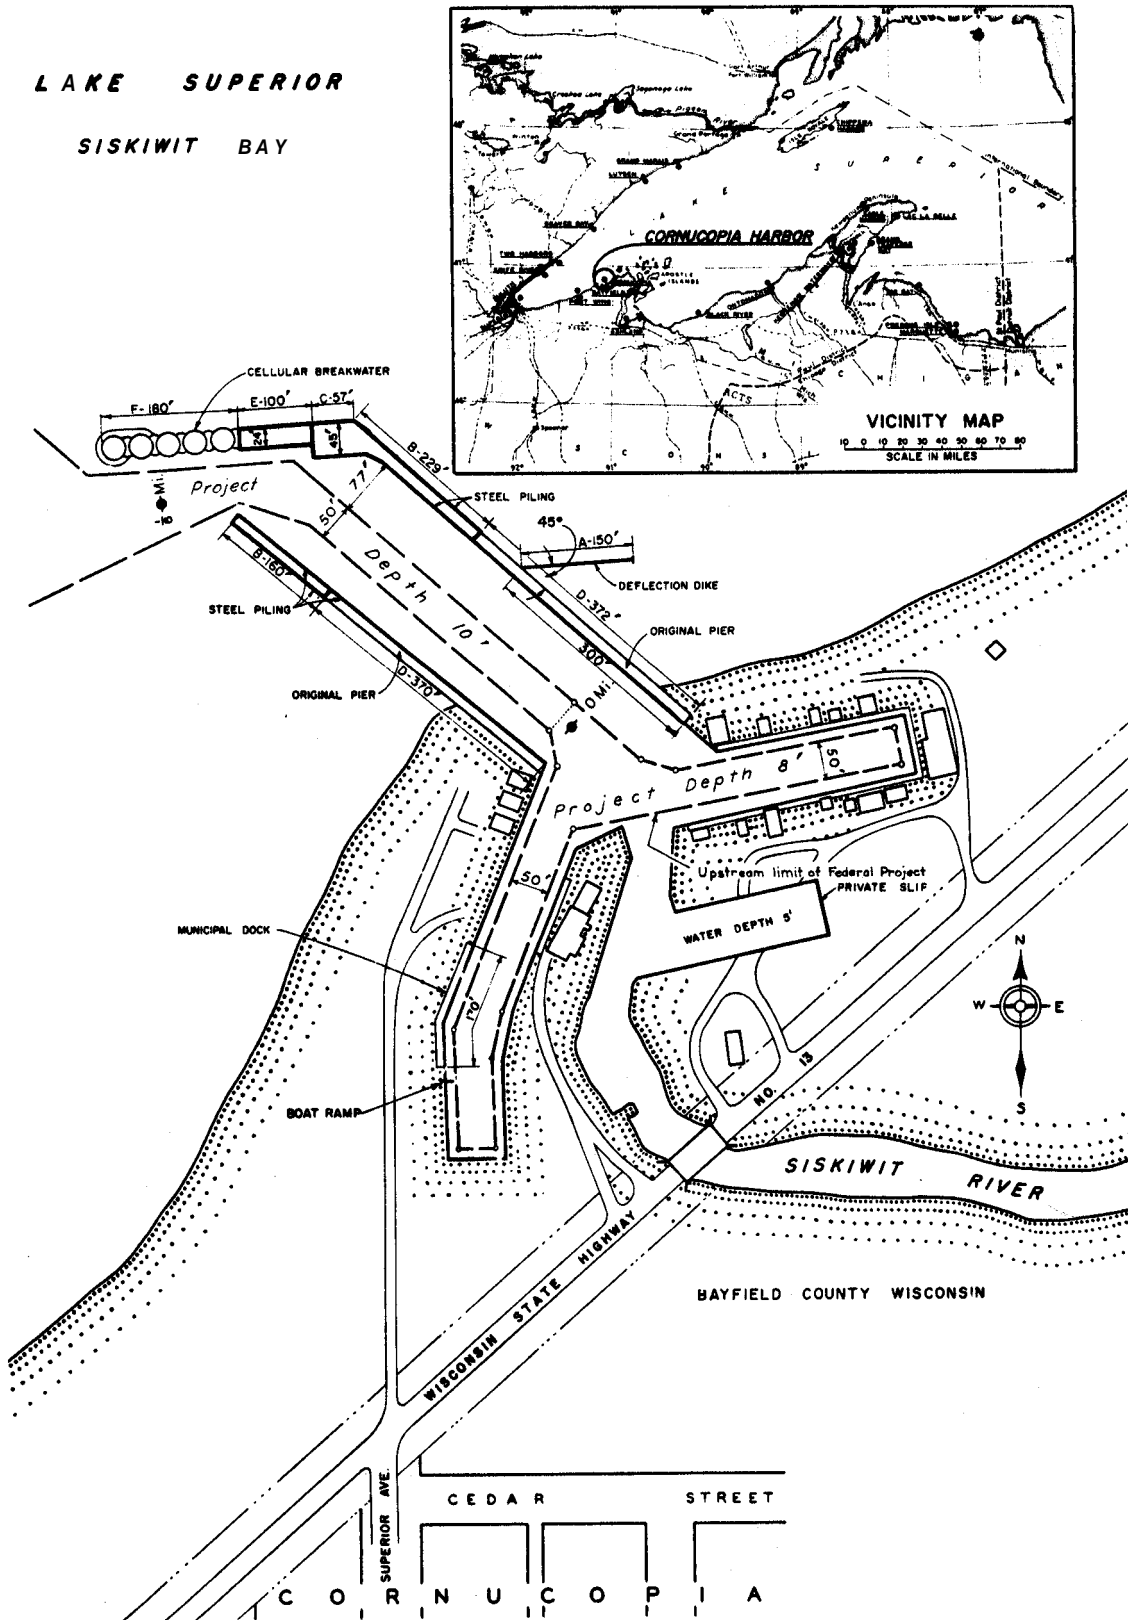
Figure 15. Cornucopia Harbor, Wisconsin

Date(s)	Construction and Rehabilitation History
1957	Construction of a 938-ft-long east pier and a 530-ft-long west pier was completed at the site (Figure 15). The shoreward 370 ft and 372 ft of the west and east piers, respectively (Figures 15 and 16, Section D), were constructed with woodpiling and filled with stone. Steel sheetpiling was installed also on the channel side at an el of +8 ft lwd. The remaining 160 ft of the west pier, and the next 286 ft of the east pier (Figures 15 and 16, Sections B and C) were constructed of woodpiling with sand and stone fill. Steel sheetpiling was installed on each side of the structure at a +8 ft el lwd. Stone was grouted in place to cap the structure. The west pier was 15 ft wide, and the east pier ranged from 17 to 45 ft in width. The next 100 ft of the east pier was constructed of steel sheetpiling with sand and rock fill (Figures 15 and 16, Section E). This structure was 24 ft wide with a crest el of +8 ft lwd. The outer 180 ft of the east pier was a cellular sheet-pile structure (Figures 15 and 16, Section F). The cells were filled with dredged sand or gravel and capped with 2 ft of rocks filled with grout. The diameter of the cells was 30.55 ft, and the crest el was +8 ft lwd. Rock berms were placed at the toe of the structure on both sides.

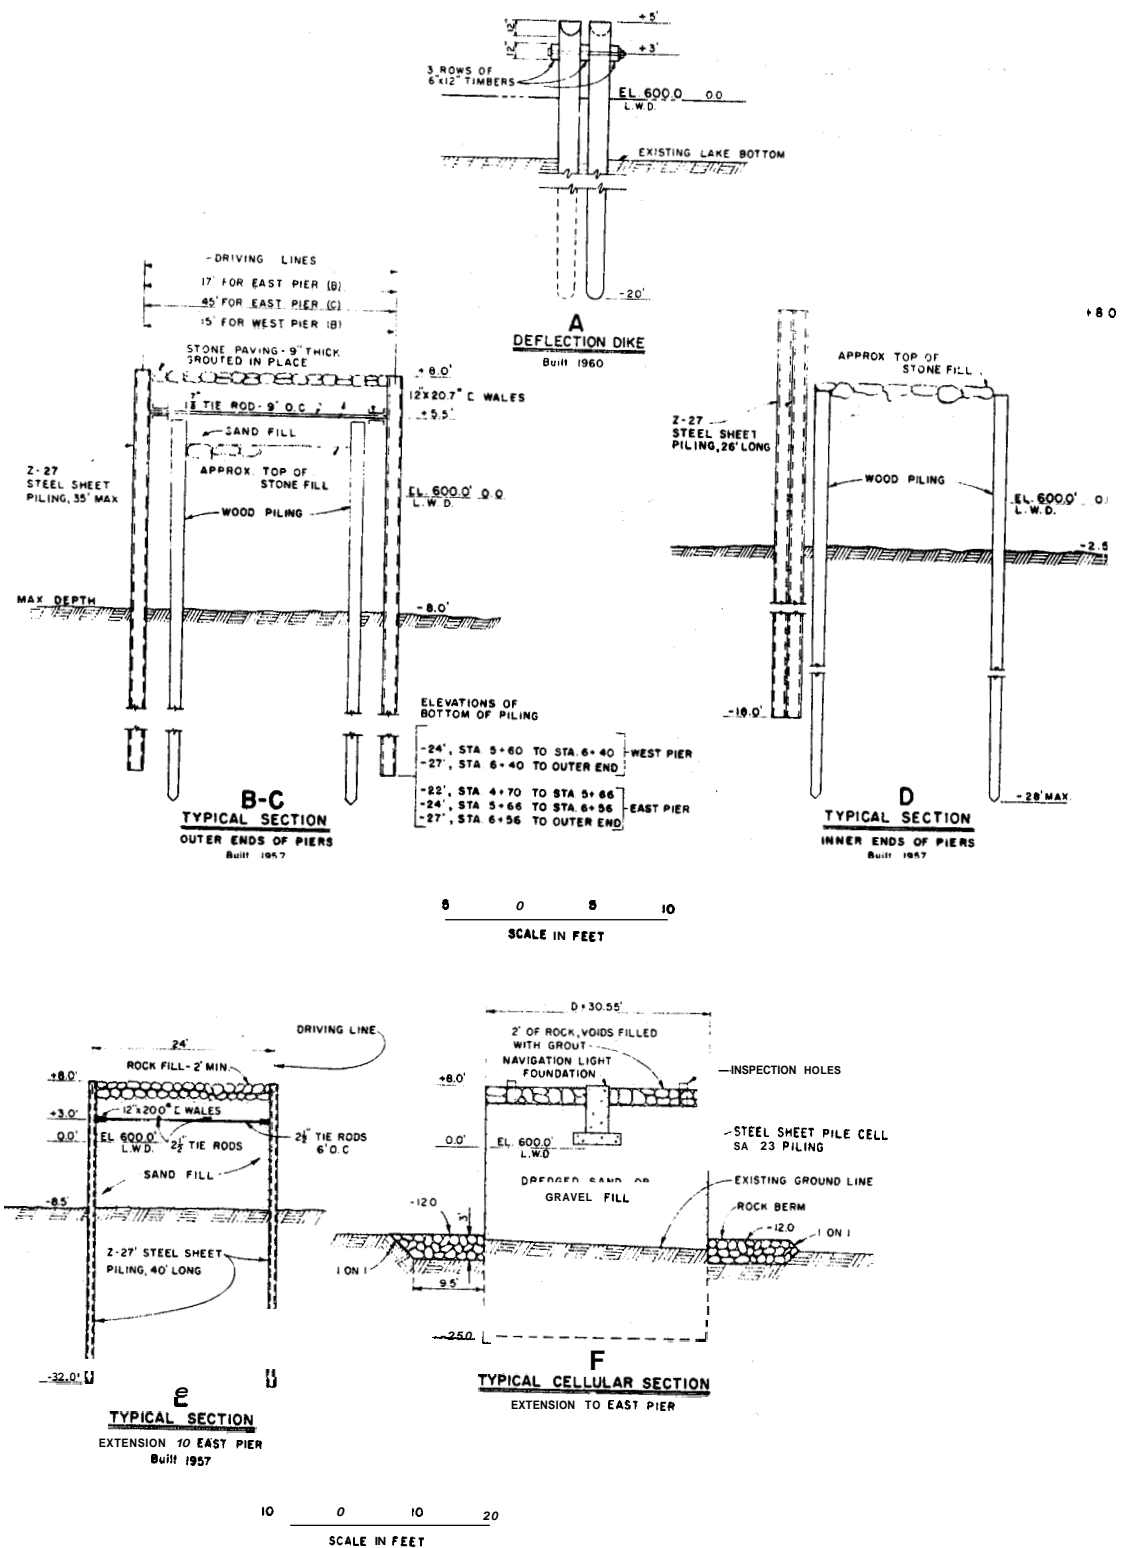
Figure 16. Typical structure cross sections, Cornucopia Harbor, Wisconsin

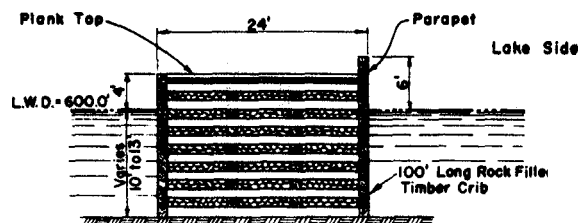
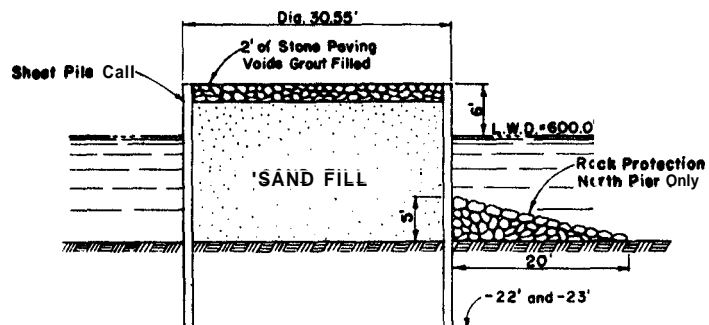
A. City pier 465' long built 1936 by W.P.A.  
184' of parapet added 1960

B. City Breakwater and City Pier EII built 1941  
Superstructure rebuilt and parapet added 1960

Built 1960

Figure 18. Typical structure cross sections, Bayfield Harbor, Wisconsin

Date(s)	Construction and Rehabilitation History
1936	A 465-ft-long pier (Figure 17, Section A) was constructed by the State of Wisconsin. The pier was a rock-filled timber crib structure that was 24 ft wide and had a crest el of +4 ft lwd (Figure 18, Section A).
1941	A 200-ft-long city pier ell and a 459-ft-long city breakwater pier (Figure 17, Section B) were constructed by the State of Wisconsin. The structures had the same cross sections as the pier built in 1936.
1960	A 103-ft-long extension of the city pier ell and a 139-ft-long extension of the city breakwater pier were completed by the Corps. The extensions were of cellular sheet-pile construction. The cell diameters were 30.55 ft in width and had a +6 ft lwd crest el. They were sand filled with a grout-filled stone cap. Toe protection was provided on the lakeward side of the north extension only (Figures 17 and 18, Section C). The Corps also built a parapet wall totaling 843 ft in length on the existing piers. The crest el of the parapet was +6 ft lwd.

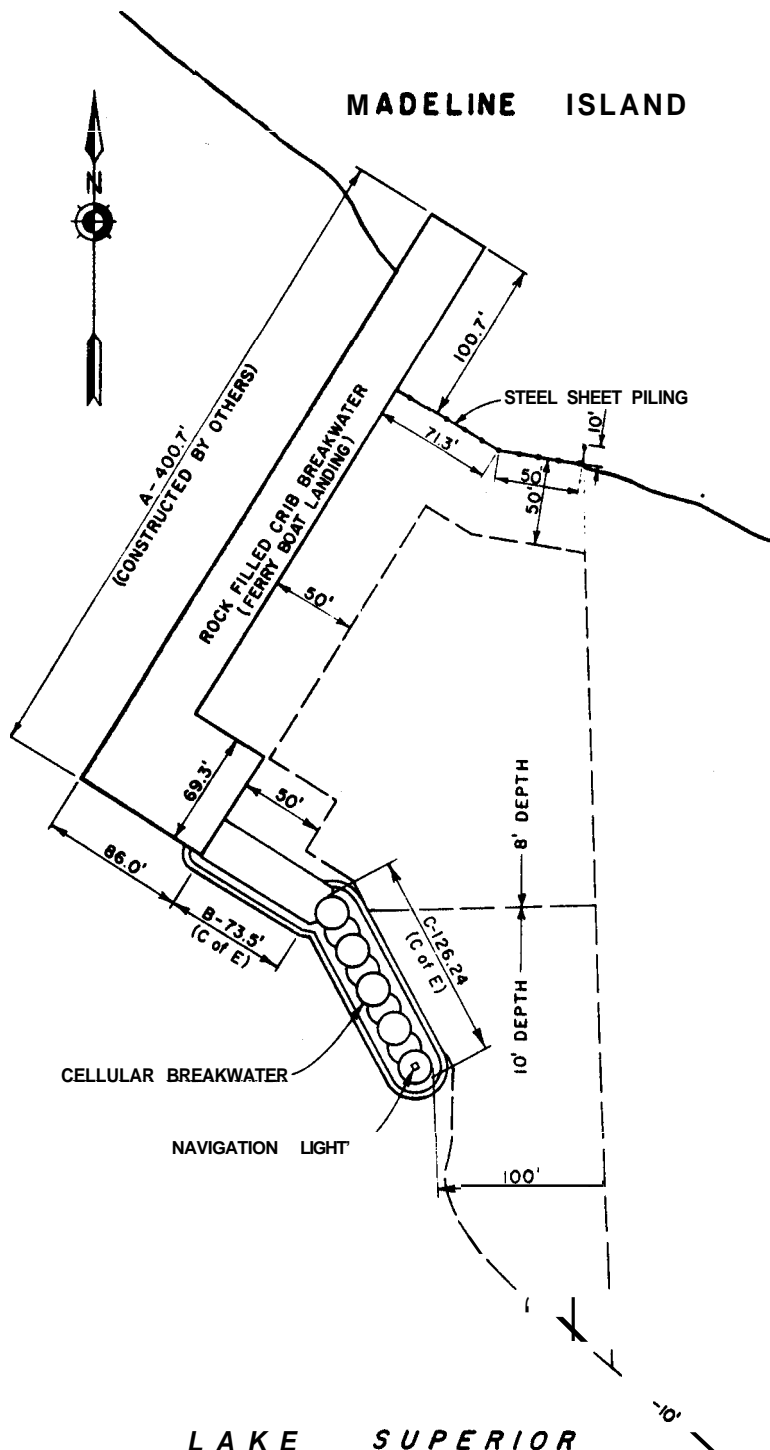
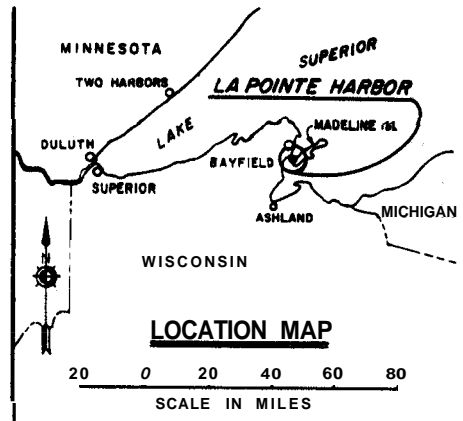
Figure 19. La Pointe Harbor, Wisconsin

Date(s)	Construction and Rehabilitation History
1967	A 200-ft-long extension of an existing rock-filled timber crib breakwater was completed by the Corps (Figure 19). The existing structure was <b>37.3</b> ft wide with a crest el of <b>+4</b> ft lwd. It was constructed by local interests (Figures 19 and 20, Section <b>A</b> ). The initial <b>74</b> ft of the extension was built with steel sheetpiling that was sand filled and capped with stone (Figures 19 and 20, Section B). It was <b>25 ft</b> wide with a crest el of <b>+7</b> ft lwd on the lakeside and <b>+4</b> ft lwd on the harbor side. The lakeward 126-ft length of extension was a cellular sheet-pile structure with cell diameters of 20.36 ft. They were sand filled and had stone caps (Figures 19 and 20, Section C). The crest el of the sheet pile was <b>+7</b> ft lwd on the lakeside and ranged from <b>+4</b> to <b>+7</b> ft lwd on the harbor side. Riprap was placed along the toe of the cellular structure.

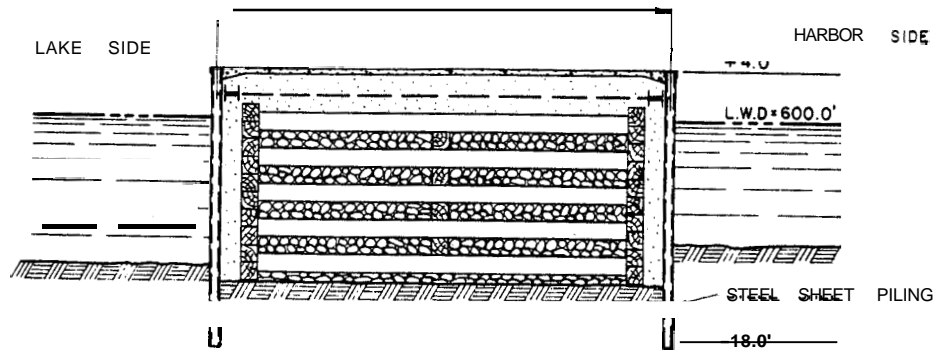
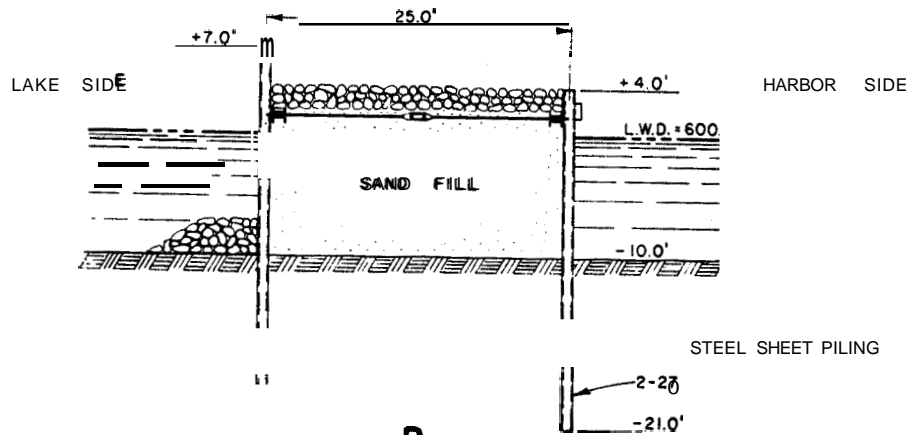
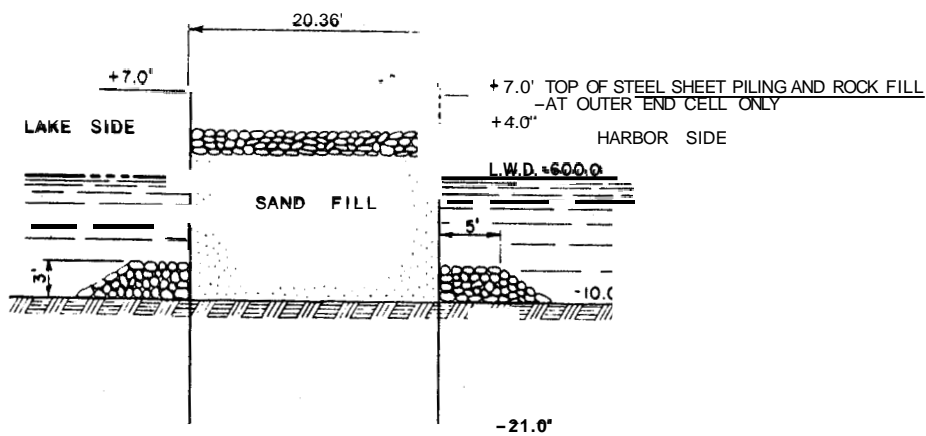
TIMBER CRIB 400.7'  
(COMPLETED BY OTHERS)

STEEL SHEET PILING 73.5'  
(CORPS OF ENGINEERS)

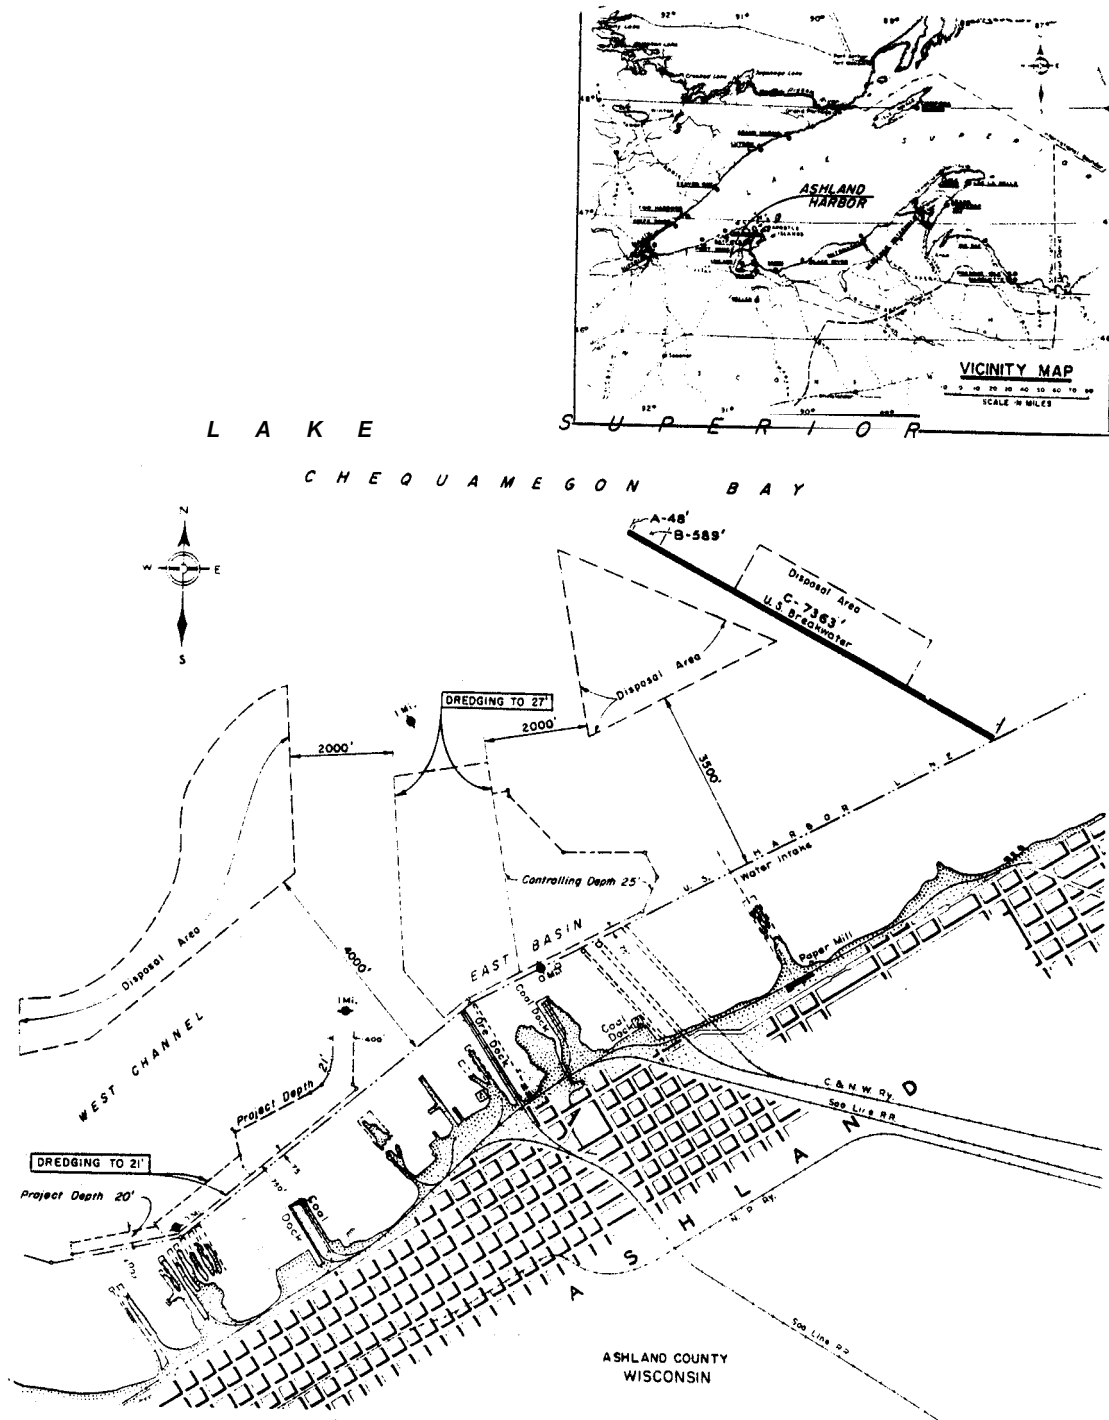
Figure 21. Ashland Harbor, Wisconsin

Date(s)	Construction and Rehabilitation History
1889- 1894	Construction of a 7,363-ft-long timber crib breakwater progressed at the site (Figures 21 and 22, Section C) during this time. The structure was filled with timber slabs and capped with stone. It had a crest width ranging from 20 to 28 ft and was installed at el +7 ft lwd.
1908- 1910	Stone reinforcement was installed on both sides of the structure (Figure 22, Section C) on a slope of <b>1V:1.5H</b> .
1911	A timber crib pierhead was constructed. The structure was stone and timber filled, 32 ft wide, and 48 ft long. Riprap toe protection was included (Figures 21 and 22, Section A).
1912- 1913	A 589-ft-long rubble-mound breakwater was built during this period. The structure connected the pierhead to the original breakwater (Figure 21, Section B). It had a +7 ft lwd crest el with a 10-ft-width (Figure 22, Section B). Side slopes were approximately 1V:1H.
